# Manhole Inspection Summary

Manhole # S27S\_\_011MH

Insp Date: **4/24/08 2:53 PM**

**Location** Address: **1800 Bayard ST**

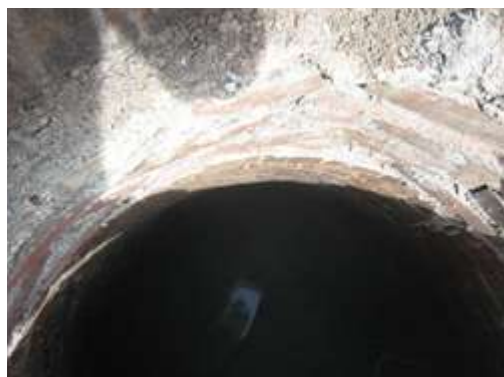
Defect 3

**Frame** Offset: **2** (in.) Condition: ☒ Sound ☐ Cracked ☐ Leaks

2 offset

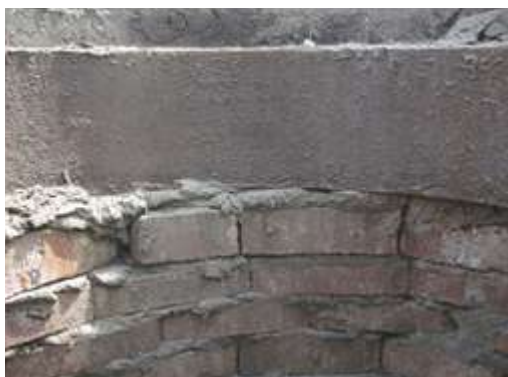
Defect 2

Condition: ☐ Sound ☐ Cracked ☐ Root Intrusion ☒ **Loose Brick** ☐ Deteriorated

missing mortar

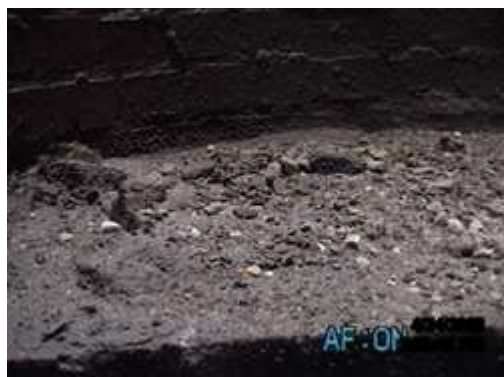
Defect 1

Condition: ☐ Sound ☐ Cracked ☐ Root Intrusion ☐ Deteriorated ☐ Leaks ☒ **Debris**

debris on bench

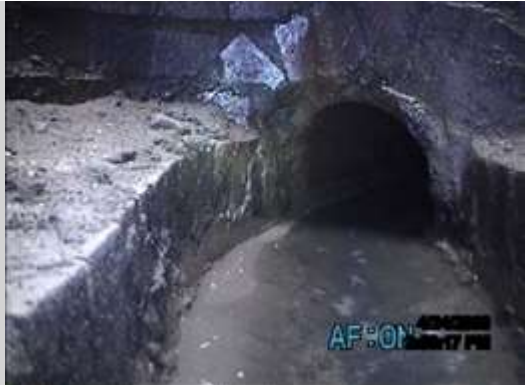
12 O'Clock Outflow

10 in. Circular Gravity Sewer  
Pipe Out @ 12 O'Clock

Pipe Height: **10.8** (in.) Rod and Bar (Angled)  
Pipe Material: **Clay** ☐ Pipe Lined  
Invert Depth: **13.01** (ft.) Flow Characteristics: **Slow**  
Deposits: ☒ None ☐ Mud ☐ Sludge ☐ Debris ☐ Grease  
Silt Depth: **0** (in.) Deposits Extent:  
Infiltration: **Evidence** Pipe Seal Cond: **Unknown**

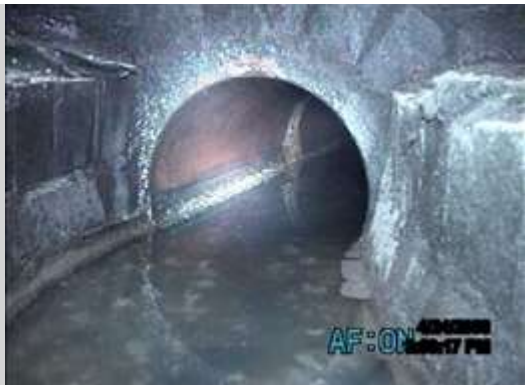
6 O'Clock Inflow

12 in. Circular Gravity Sewer  
Pipe In @ 6 O'Clock

Pipe Height: **12** (in.) Rod and Bar (Angled)  
Pipe Material: **Clay** ☐ Pipe Lined  
Invert Depth: **13.15** (ft.) Flow Characteristics: **Slow**  
Deposits: ☒ None ☐ Mud ☐ Sludge ☐ Debris ☐ Grease  
Silt Depth: **0** (in.) Deposits Extent:  
Infiltration: **Evidence** Pipe Seal Cond: **Unknown**
